Bridge Scour Monitoring Methods at Three Sites in Wisconsin

Open-File Report 2005–1374

By John F. Walker and Peter E. Hughes

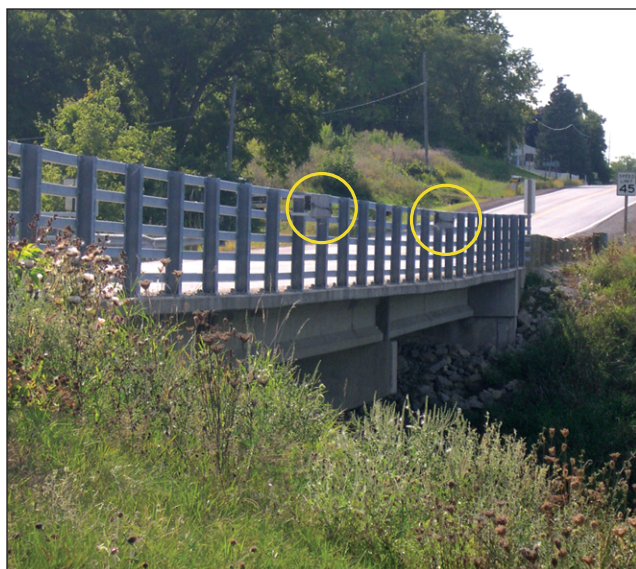
Figure 2. Wire-weight gages (circled) on the County B bridge over the Crawfish River in Jefferson County, Wisconsin.

The equipment installed at the site consists of two manual wire-weight gages, installed on the upstream rail of the bridge (fig. 2) in line with the two piers. The gages contain a calibrated reel which displays the distance from

the reel to the weight using a series of counters. The gages are operated by lowering the weight to the water surface and then to the streambed, and the distances from the gage to each surface are recorded on a field form. The gages can be read to within 0.01 ft (0.3 cm), but the accuracy of distance to the streambed is probably on the order of 0.05 ft (1.5 cm). The measurement accuracy will depend upon the technique used to drop the weight to the streambed without allowing it to be carried a substantial distance downstream during high-flow conditions. A 10-lb (4.5 kg) downrigger ball was selected to minimize this problem. Measurements were collected approximately monthly from March through May of 2003, and in May and June of 2004. The cost of the equipment in 2002 was approximately \$3,000, and the cost of installation and operation for a one-year period was approximately \$3,300.

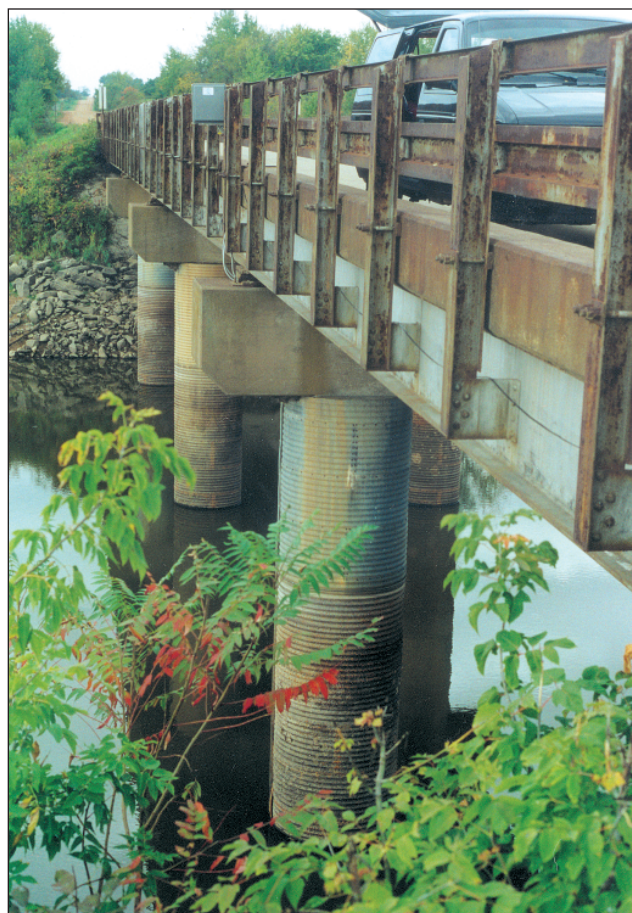
Figure 3. Photograph showing the Balsam Road bridge over the Big Eau Pleine River in Marathon County, Wisconsin.

The Balsam Road bridge spans the Big Eau Pleine River in Marathon County (fig. 3). Currently (2005) the

bridge has been removed, and a new structure is being built. The old bridge, which was built in 1939, consisted of four spans supported by three piers founded on 30-ft (9-m) timber piles which were driven to the point of refusal. The bridge had an overall length of 220 ft (67.1 m). The bed material consists of a 4-8 foot (1.2-2.4 meter) layer of sand with a varying amount of silt and gravel. Bedrock is about 25 ft (7.6 m) below the streambed. The bridge inventory for this site resulted in an NBI Item 113 code of 3, which represents an unstable foundation for calculated or estimated scour conditions.

The equipment at the site consisted of two Datasonics PSA-916 sonar transducers, mounted on the upstream and downstream edges of the eastern most bridge pier. Divers from the Marathon County Highway Department found the footing for this pier exposed above the streambed and the evidence of scour was much more pronounced than at the other piers. The transducers were connected to a Campbell Scientific CR10 datalogger, which recorded distance to the streambed at the two locations using a 15-minute recording interval. The stated accuracy of the sonar units is 0.083 ft (2.5 cm). Data from the Campbell datalogger was transmitted via phone to the office in Middleton, and was made available through the real-time data network (<http://wi.waterdata.usgs.gov/nwis/current/?type=scour>). The equipment was operated from June of 1998 until September of 2001. The cost of the equipment in 1997 was approximately \$4,800, the installation cost was approximately \$4,200, and the annual cost of operation of the equipment was \$4,000.

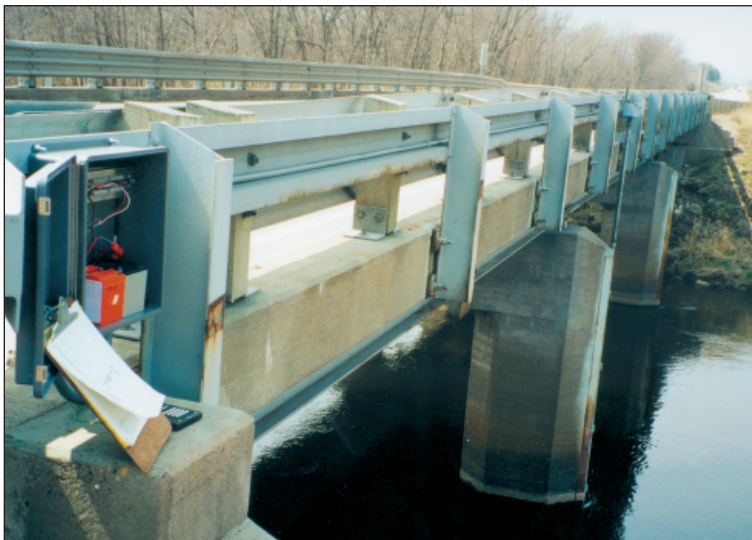
Figure 4. Photograph showing the Wisconsin Highway 35 bridge over Tank Creek in Trempealeau County, Wisconsin.

The Wisconsin Highway 35 bridge spans Tank Creek in Trempealeau County (fig. 4). The bridge, which was built in 1951, consists of 3 spans supported by 2 piers founded on spread footings. The bridge has an overall length of 130 ft (40 m). During the 1993 floods the footings and some length of the piles were exposed. As a countermeasure, the streambed sediments in the vicinity of the piers and footings were armored with 8–18 in. (20–46 cm) breaker-run rock in an attempt to control the scour at the site. The bridge inventory for this site resulted in an NBI Item 113 code of 3, represents an unstable foundation for calculated or estimated scour conditions.

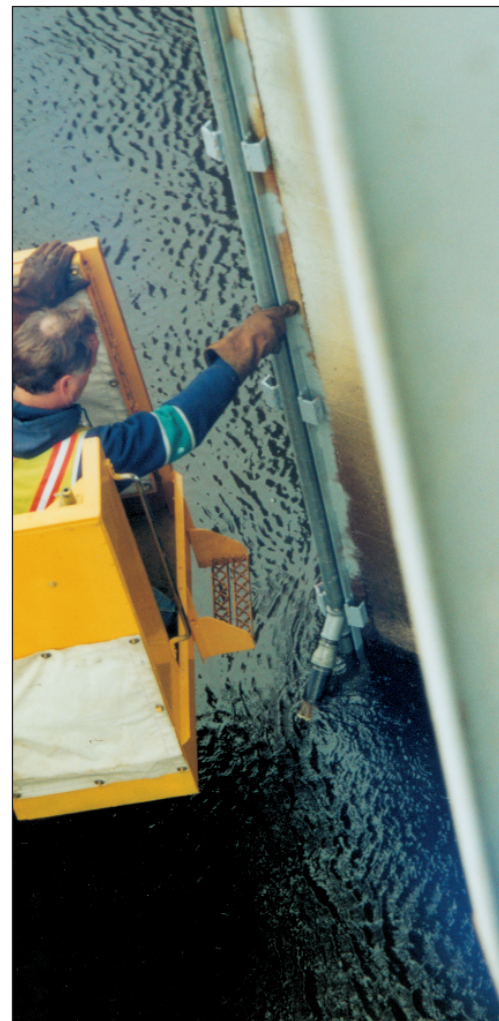
Figure 5. Photograph showing the transducer mount on the upstream edge of the pier, Tank Creek installation.

The equipment at the site consists of a Datasonics PSA-916 sonar transducer, mounted on the upstream edge of the eastern-most bridge pier (fig. 5). WisDOT had indicated that the scour in the past had been more pronounced at this pier. The transducer was connected to

The Tank Creek bridge has wedge-shaped piers with an embedded channel iron at the upstream face. This provided an ideal surface for welding a transducer mounting system that allows the transducer and cable to be protected from debris damage, holds the transducer in position above the streambed, and allows for easy removal for repair. There has been no damage to this system since its installation.

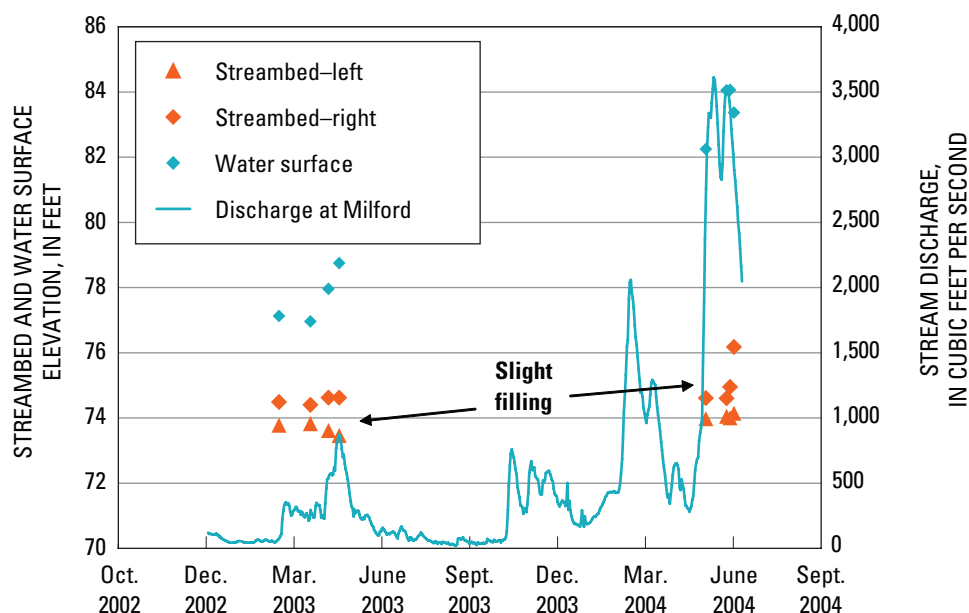
Figure 6. Scour measurements at the County B bridge over the Crawfish River. The discharge hydrograph is from the gage at Milford, 2.2 mi (3.5 km) upstream of the bridge.

The results for the monitoring at the County Highway B Bridge over the Crawfish River are presented in figure 6. The discharge from the gage at Milford, located 2.2 mi (3.5 km) upstream of the bridge, is included for reference as an indication of the magnitude of the flow events during the periodic monitoring. For the monitoring period from March to May of 2003, during conditions of increasing discharge, the streambed was scouring slightly on the left pier, and filling slightly on the right. This pattern indicates variation in local velocities in the vicinity of the

piers. For the subsequent monitoring period in May and June of 2004, the streambed was filling in the vicinity of both piers, even though there was a fairly substantial flow event at the Milford gage. Based on frequency analysis using data through the 2000 water year (Walker and Krug, 2003), the event in February 2004 approached the two-year discharge, and the event in March 2004 had a recurrence interval between 5 and 10 years. Insufficient data exist to determine if the streambed is still recovering from the bridge construction activities during the previous year or if the measured streambed aggradation is typical for the experienced flows. Over the entire monitoring period, there has been some slight filling of the channel on the order of 0.5 ft (0.15 m).

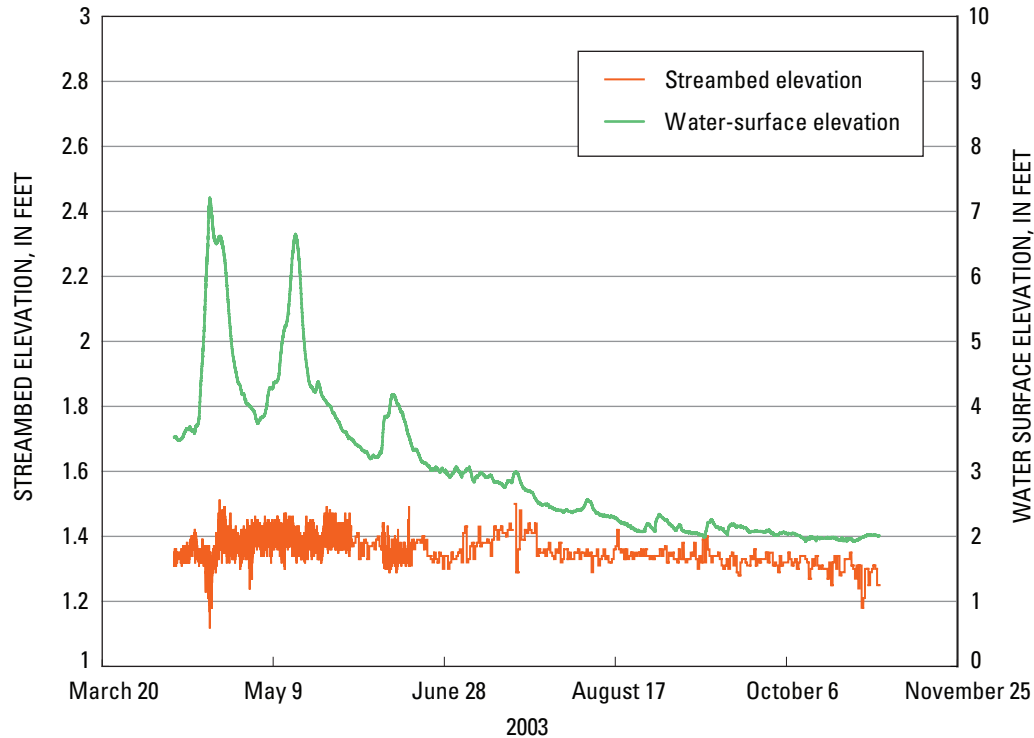
Figure 8. Continuous scour measurements from the upstream transducer at the Wisconsin Highway 35 bridge over Tank Creek.

Selected results for the continuous monitoring at the Wisconsin Highway 35 bridge over Tank Creek are presented in figure 8. Note that the water-surface elevation, an indication of the discharge and associated velocities, was

collected at the site, thus there should be a good association between the hydrograph and the associated change in the streambed. For the period displayed, however, there is very little change in the streambed. This is largely due to the armoring provided by the rip-rap installed at the site prior to installation of the monitoring equipment. Periodic manual inspections of the elevation of the streambed in the vicinity of the upstream pier has confirmed that there has been little net change in the streambed elevation. Note that the “noise” in the signal is a fairly good indication of the uncertainty of the monitoring equipment. For the most part, one could conclude that the measurements recorded by the transducer had an uncertainty of less than 0.1 ft (3 cm), which is somewhat less than the accuracy stated in the specifications, but well within limits needed for monitoring streambed scour.
